THE DOCUMENTATION AND RESTORATION PROPOSAL FOR DEDE SULTAN TURKISH BATH LOCATED IN KASTAMONU, TURKEY

Ercan AKSOY*

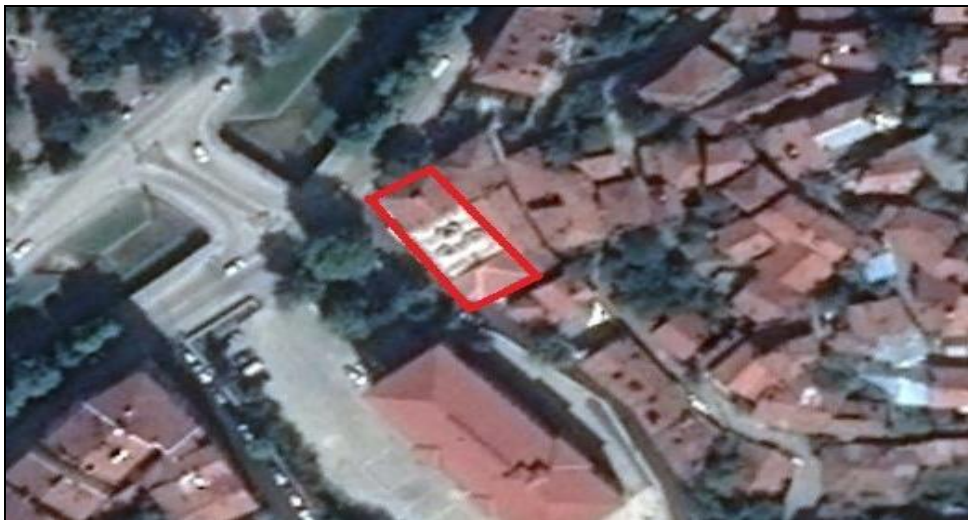
Figure 2. Aerial photograph of the building.

The building is located in the central district of Kastamonu, İsfendiyar neighborhood, block 35, and island 207 parcel 1. The building found between the crossing points of 125. Yıl Atatürk Street and Kaybılar road is currently being used as a Turkish bath by a person. With a road running north and east, there is a dead-end street used for entrance to the apartment in the south and an apartment one meter away. (Fig.2).

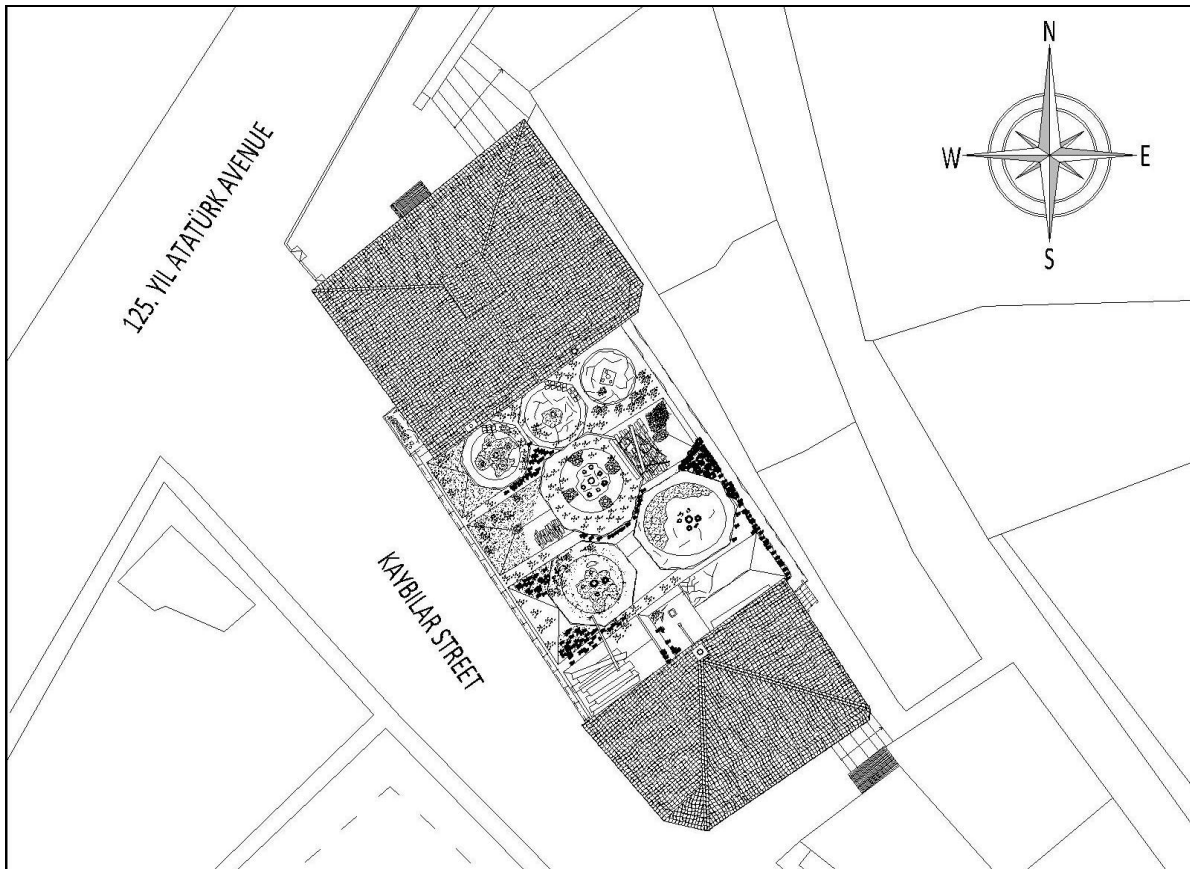
Figure 3. Dede Sultan Turkish bath site plan (survey)

The Dede Sultan Turkish Bath fully occupies its' plot and doesn't have a garden. The building stretches from the north to the south and the entrance occupies the main road. Especially because of the building close to the east front, the building can't be completely perceived. A building made on a dead end street on the south front also hinders the front. (Fig.3,4).

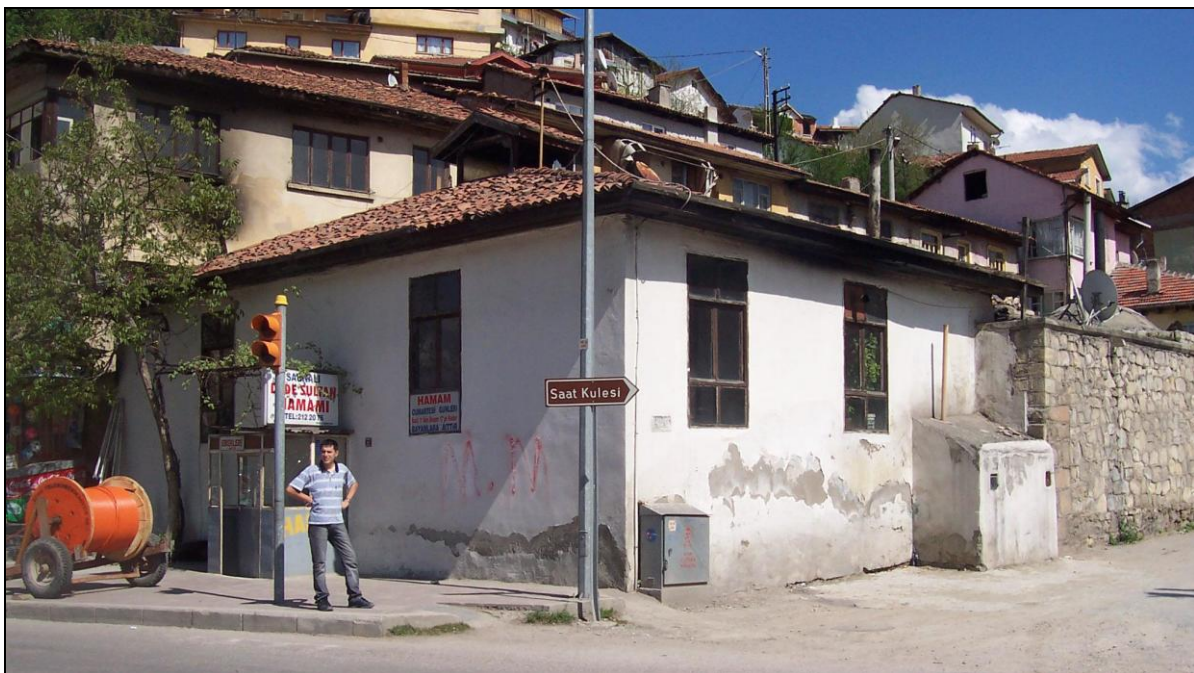
Figure 4. Dede Sultan Turkish bath elevation

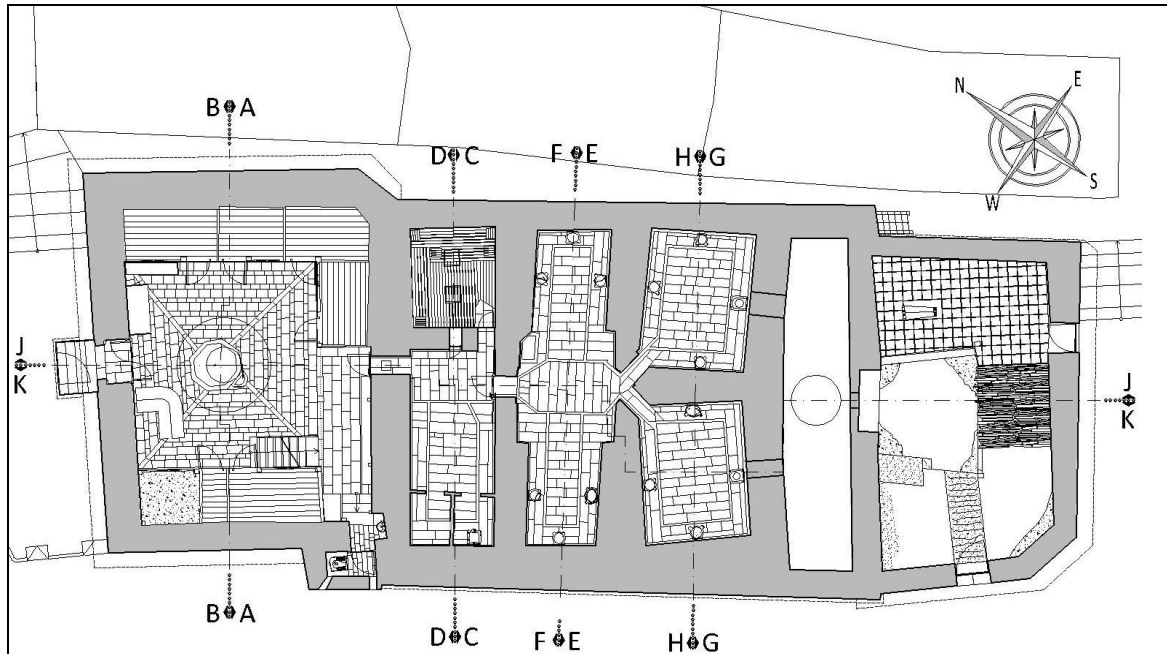
Figure 5. Dede Sultan Turkish bath Ground Floor Plan (survey).

The building has a rectangular plan and extends along the northwest – southwest axis. Inside the building, approximately 32.00 m. x 12.60 m. in dimension, sits a burial area reserved for special people in the same area as the furnace section. While the biggest part of the building is the changing room, the smallest part is the sauna area which has been built by having its originality destroyed. (Fig.5).

The building consists of nine parts: changing room, toilet, shaving room (tıraşlık), sauna, tepidarium, caldarium, water storage room, burial ground and furnace. The entrance to the building sits in the northwest and on the main road. In this front entrance of the building there is a rectangle shaped windbreak with metal profiles. Going down a two steps stair way from the windbreak and going through the wooden archway, the dressing room can be reached. The top of the wooden door has been painted with oil paint.

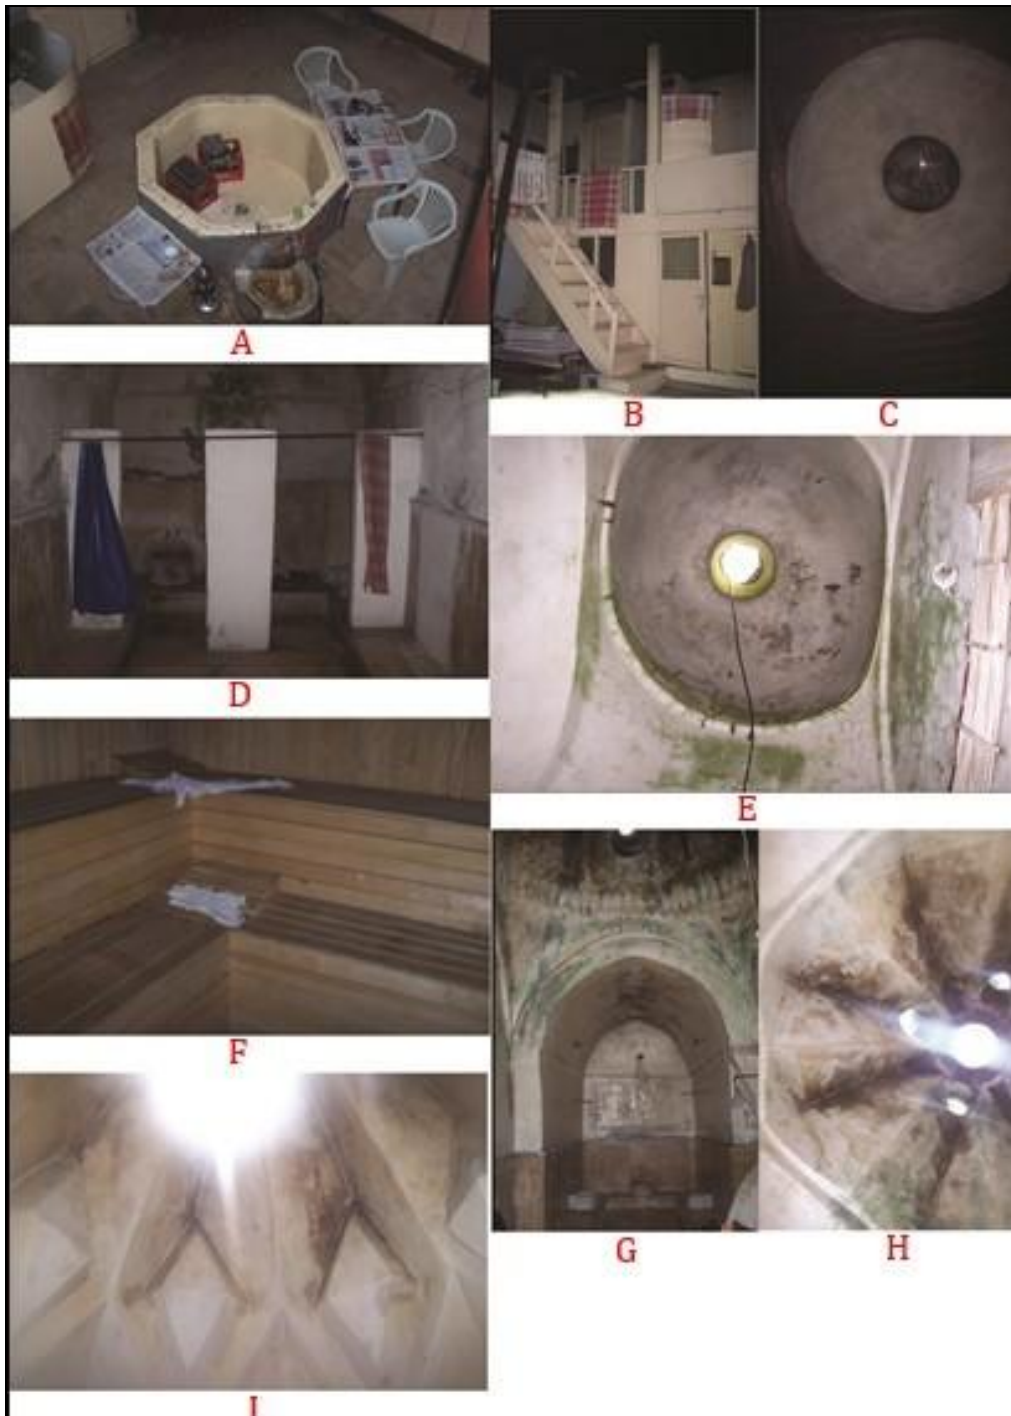
Figure 6. The current status photos of Dede Sultan Turkish bath.

The tepidarium section has a rectangular layout and the walls are covered with marble up to a certain height, the rest of the parts are lime over whitewash. On the south of this area two rooms have been made (Fig.6D). The room on the left has an original stone basin and is used as a shaving area. The room on the right has lost its function and serves as a storage room. The tiles are marble and there are two domes, one of which is an elliptical dome (Fig.6E). Small illuminations which are common features of the bath domes, show themselves here as well. Right across the shaving area there is a converted sauna room. All coatings are made of paneling with two spaces left in the ceiling for ventilation (Fig.6F).

The caldarium area reached by an arched passage, comes to front as a rectangular plan in the northeast – southwest direction. In the entrance to the room there is a small rectangle formed pool let to the left. The walls are plastered with marble covering up to a certain ridge and the upper ridges are plastered. On both wings, there are three basins each anal in the middle or the top covering is a dome, with pendentives on the sides. The elliptical egg like stone engravings used in the transition to the dome are decorative element to this structure. (Fig.6G). In the caldarium there are two “halvet” cells which run along the width of the space in the southeast section. The entrance the halvet cells are made from passages which are chamfered in shape and where the taps have an arch like form. There are bath basins, four each, on both sides of the halvet cell. While the ceiling of the halvet space in the northeast is covered with a prismatic dome made of stone reliefs resembling baklava slices (figure 5I), the ceiling of the halvet space in the southwest is covered with a dome shaped like a triangular prism (Fig.6H).

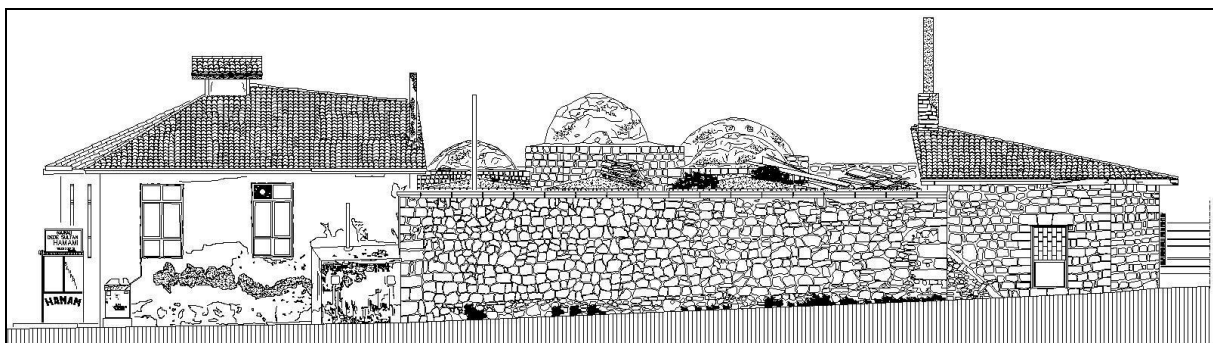
Figure 7. Dede Sultan Turkish bath southwestern façade (survey).

The structure was built as a system of masonry, in short, stone and the walls were made of rubble. The wall surfaces are plastered inside, although the changing room section is plastered, there is no plastering application elsewhere. The rooms inside the changing room can be seen as completely covered in wood. In most places the floor coverings are marble and the top cover is shaped like a dome. The roof of changing room area and furnace area is in the form of a jerkin head and covered in pantile. Above the others sections are domed and they are plastered with cement based plaster. (Fig.7).

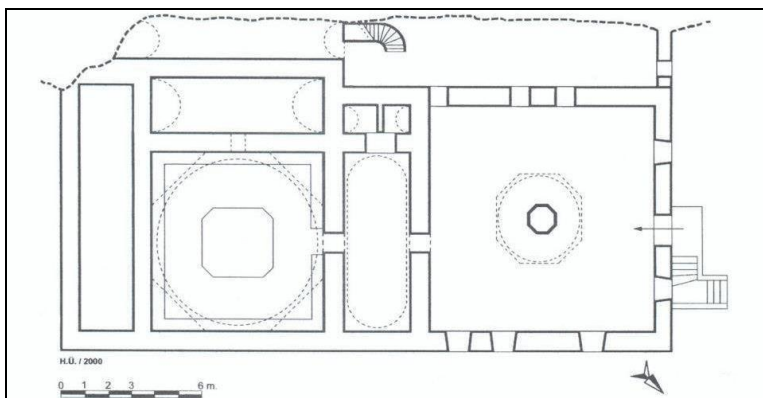
Figure 9. İzmir Hoşgör Turkish bath plan (Ürer, 2002).

When some information was being evaluated about the structure, other similar structures built at the same time period was looked at and other buildings with similar features have been referenced. The İzmir Hoşgör Turkish bath can be given as an example to the Dede Sultan Turkish bath because of its similarities of its shaving area and toilet (Fig.9). The closest example in terms of its same planning type and a domed middle, with a transverse caldarium and double halvet type is Kastamonu Double Turkish bath (Fig.10).
